Colgan Creek Restoration

In the summer of 2014, people worked to make a section of Colgan Creek more like the natural stream it used to be. This is called stream restoration.

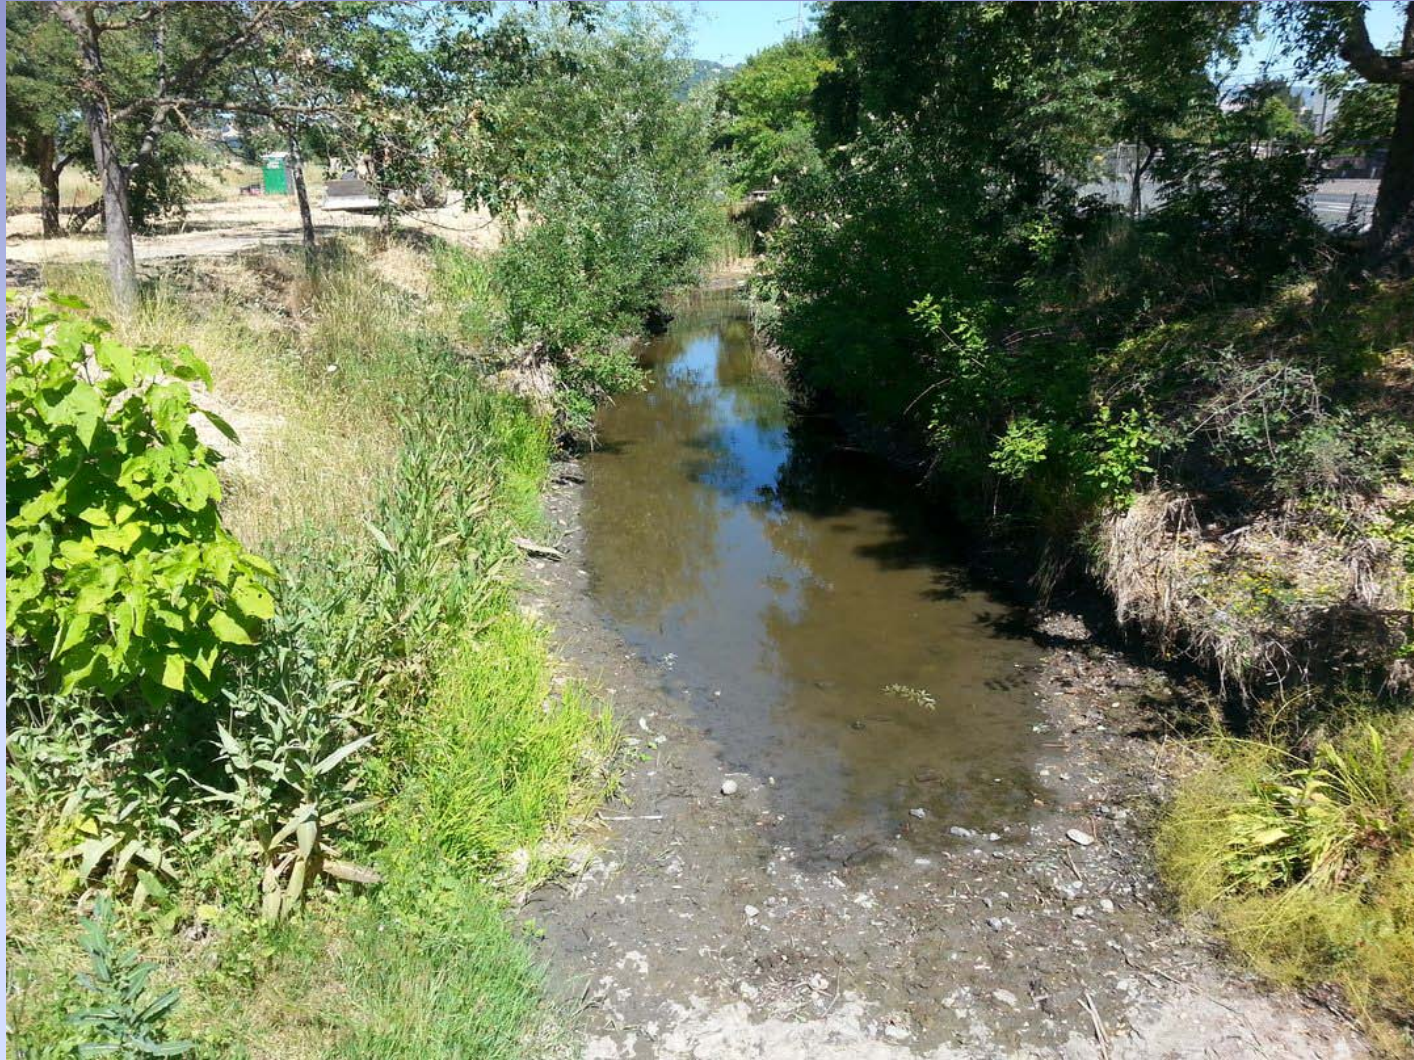
July, 2013

This is Colgan Creek before restoration. We are looking upstream, from the bridge at Burgess Avenue. The creek is straight and the channel is confined by roads on both sides.

Plants were growing in the stream channel. This leaves less room for water when there are high flows.

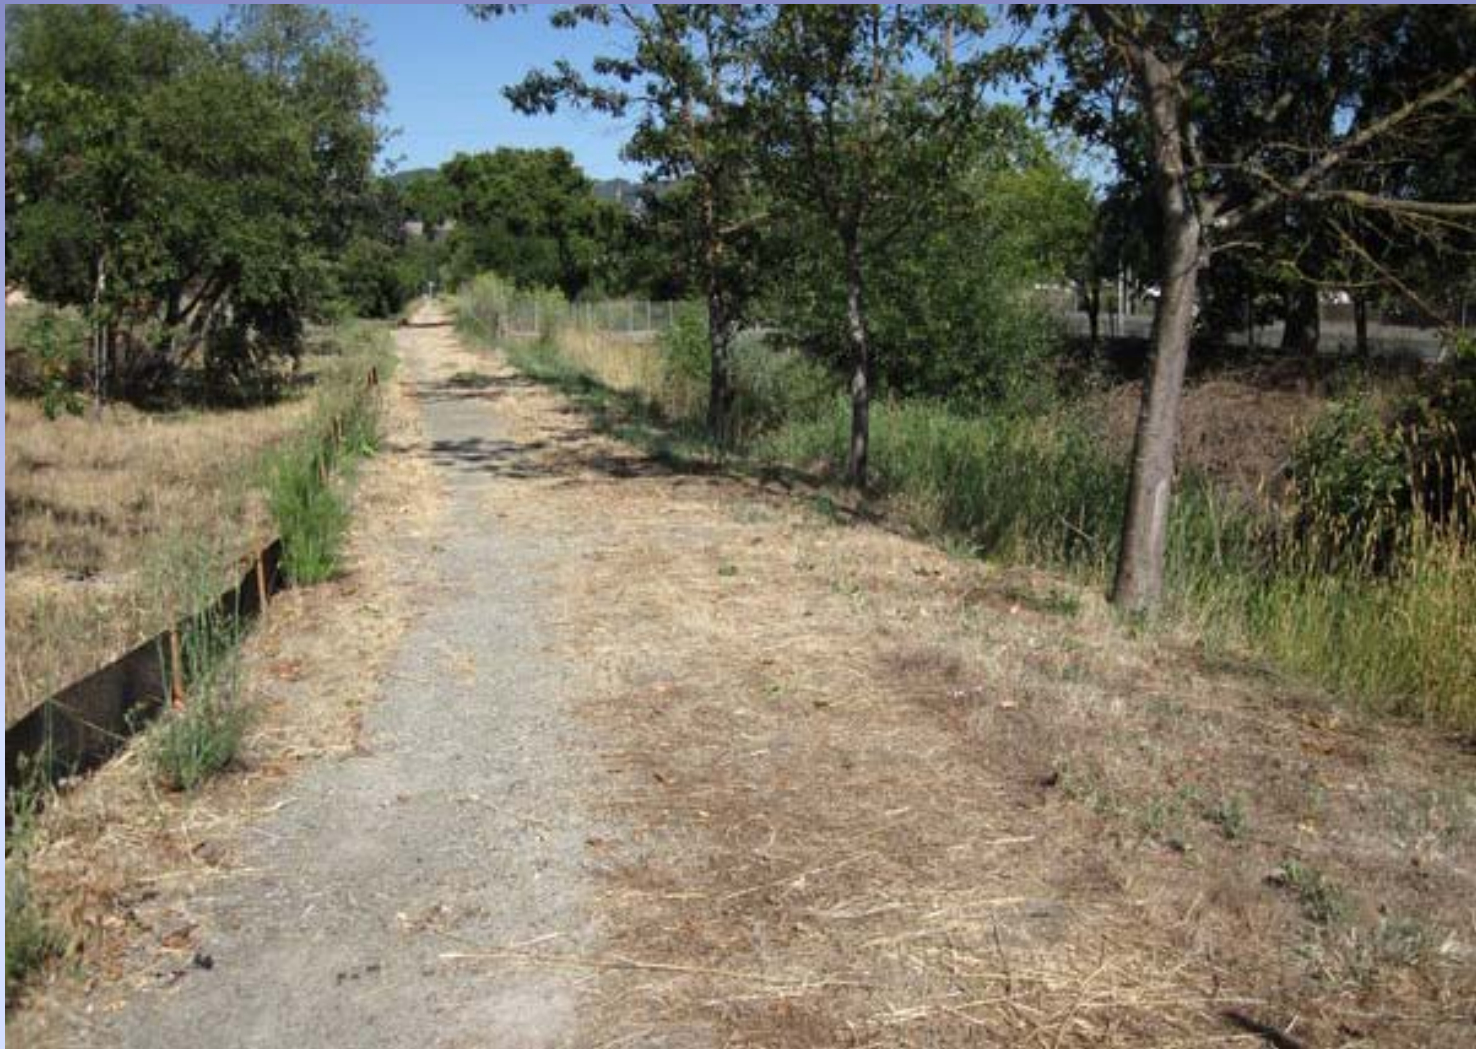
The stream was straight, like the road beside it. There were not many trees and the stream was confined in a narrow channel, to the right of the road. This area was widened to create a flood plain.

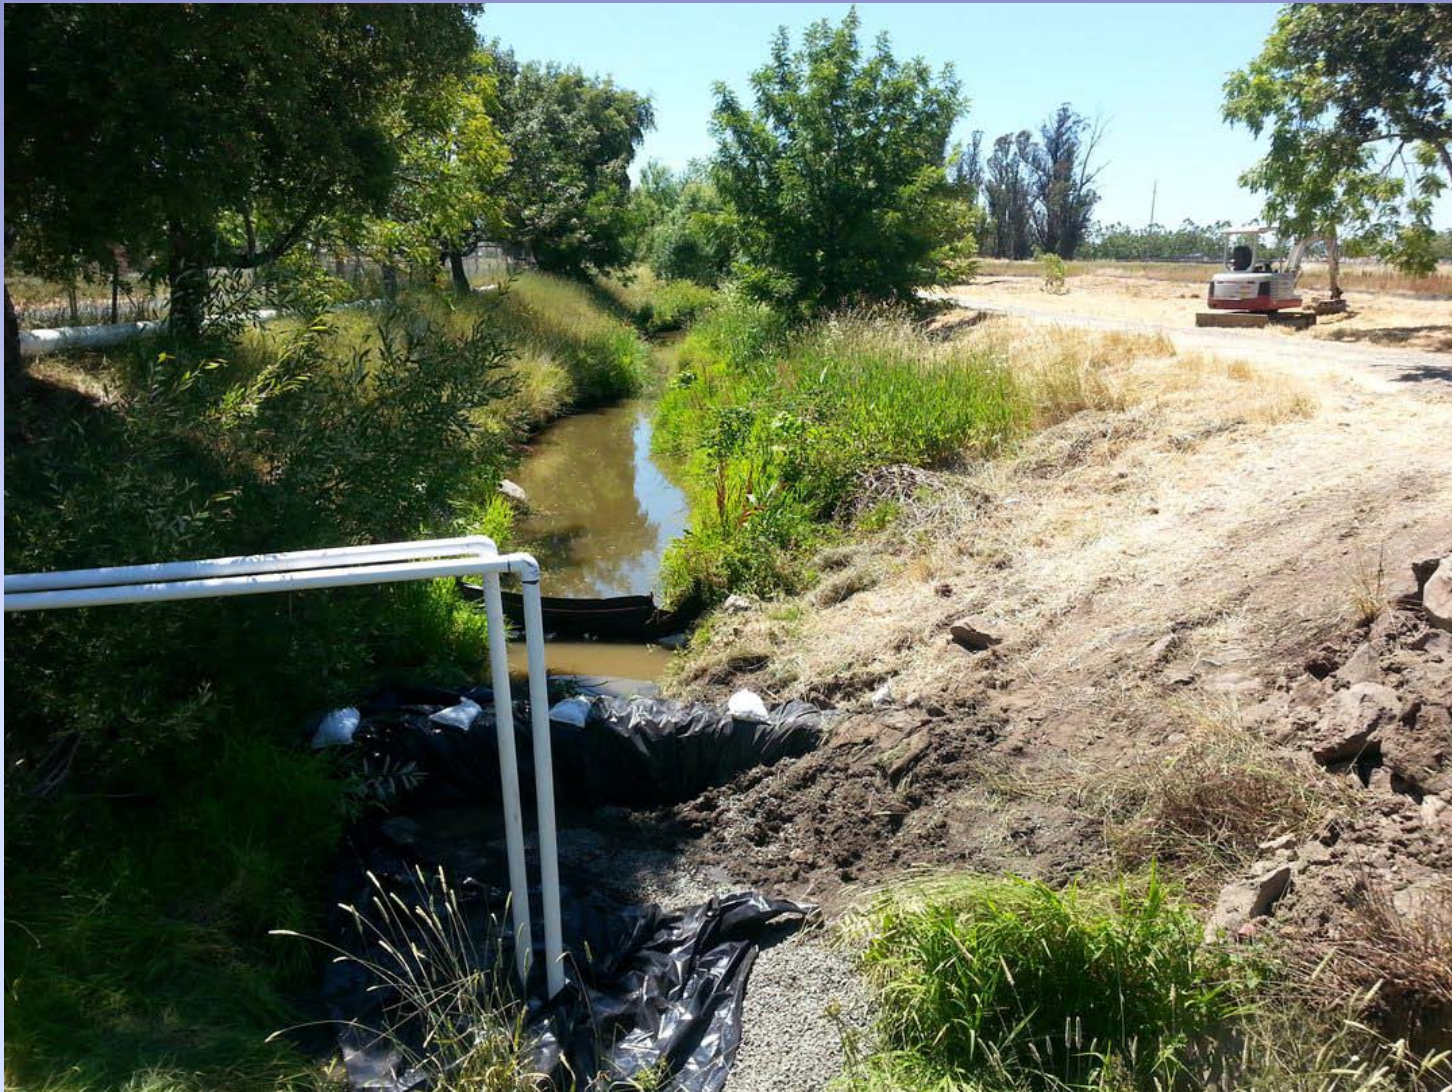
July, 2014

The summer of 2014 was dry, but the creek still had some water in it. This had to be removed before the work could begin. The water was diverted into a large pipe (upper left) that carried it past the site.

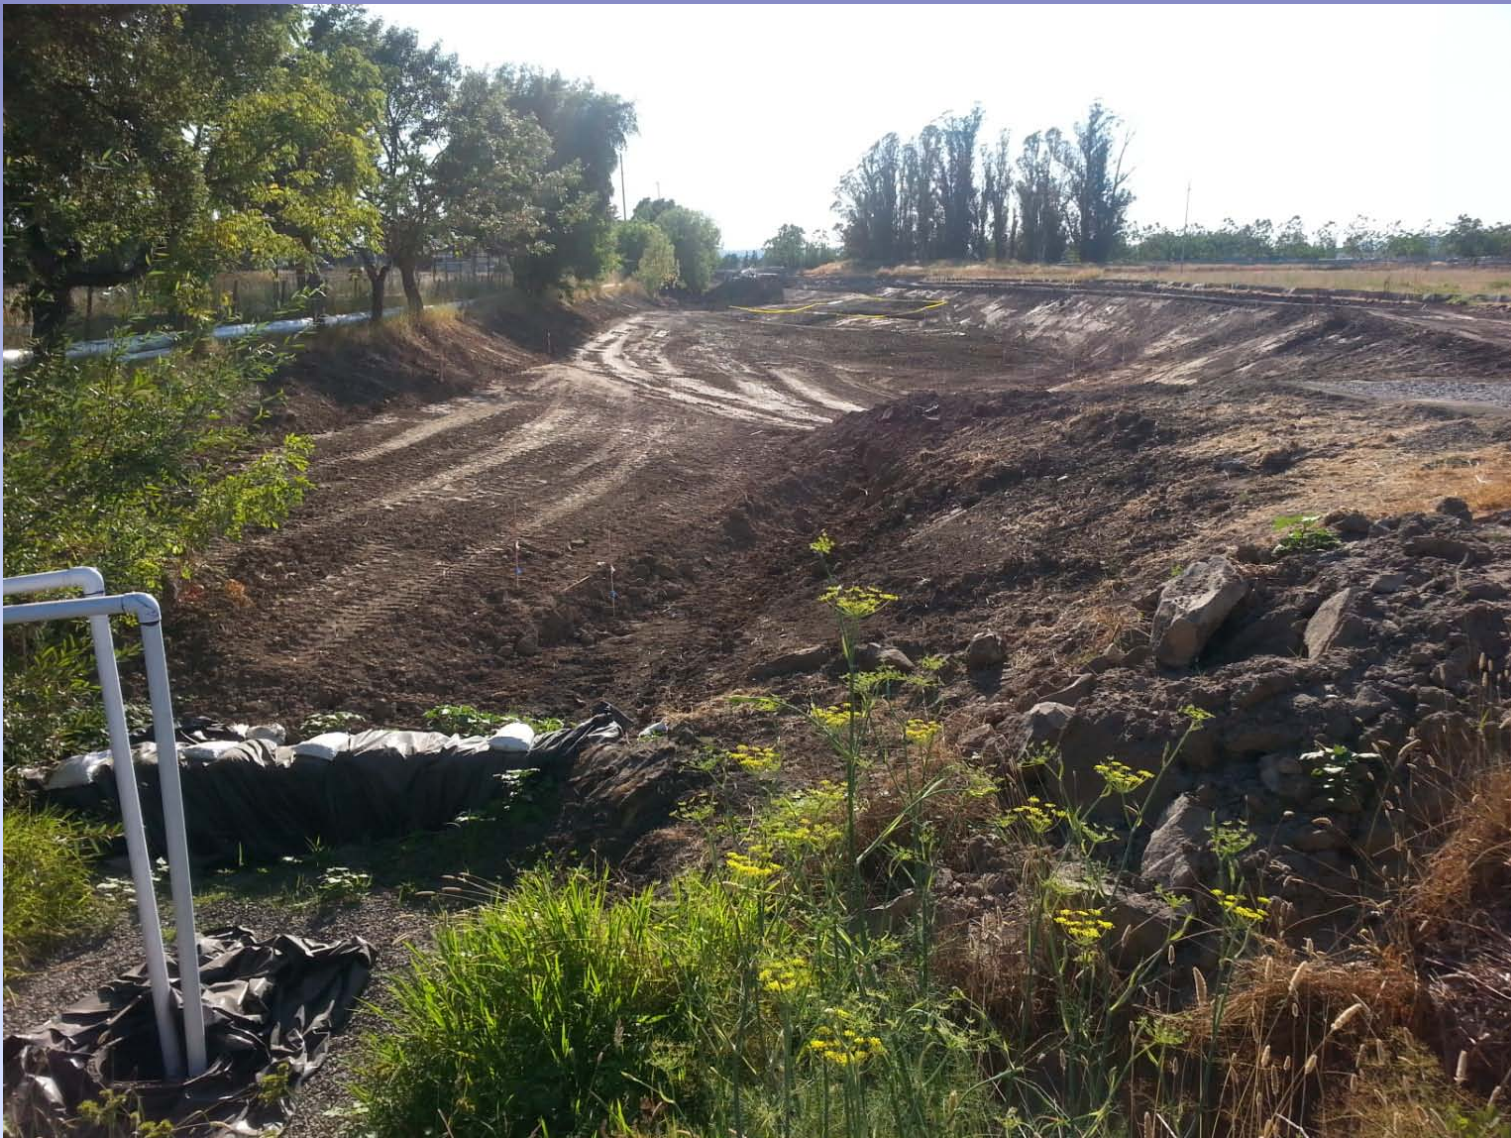
All the creek water is now flowing in the large pipe and the streambed is being reshaped.

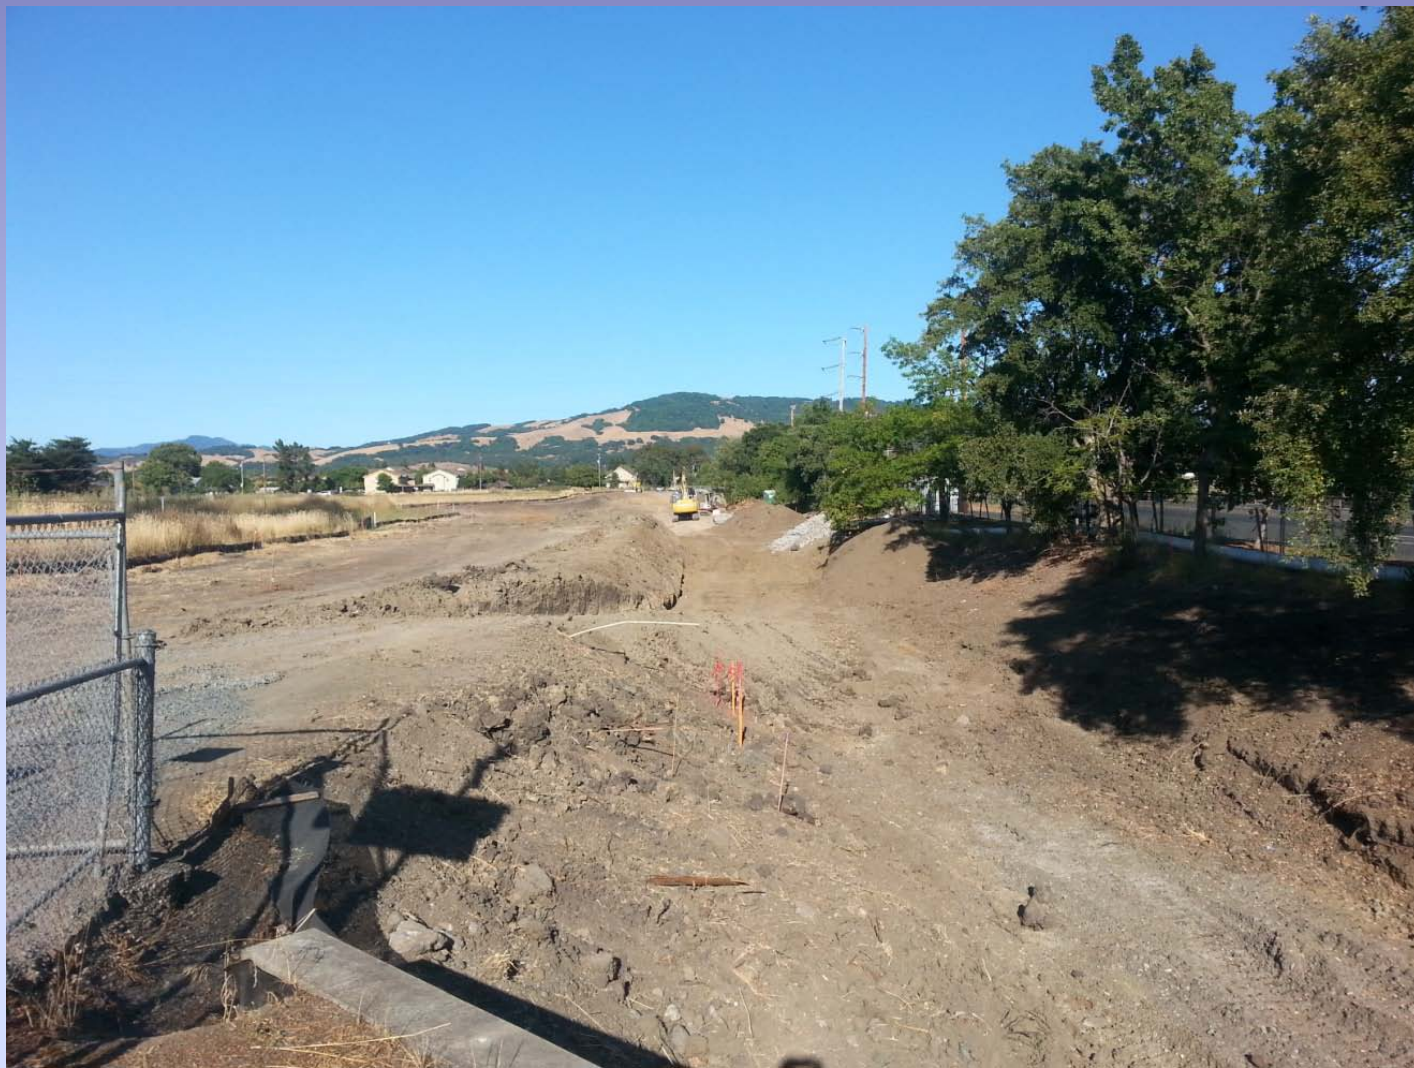
Looking toward Taylor Mountain (upstream). The dirt road that runs along the stream on the left side is being removed so the channel can be made wider. The road on the right side is Bellevue Avenue.

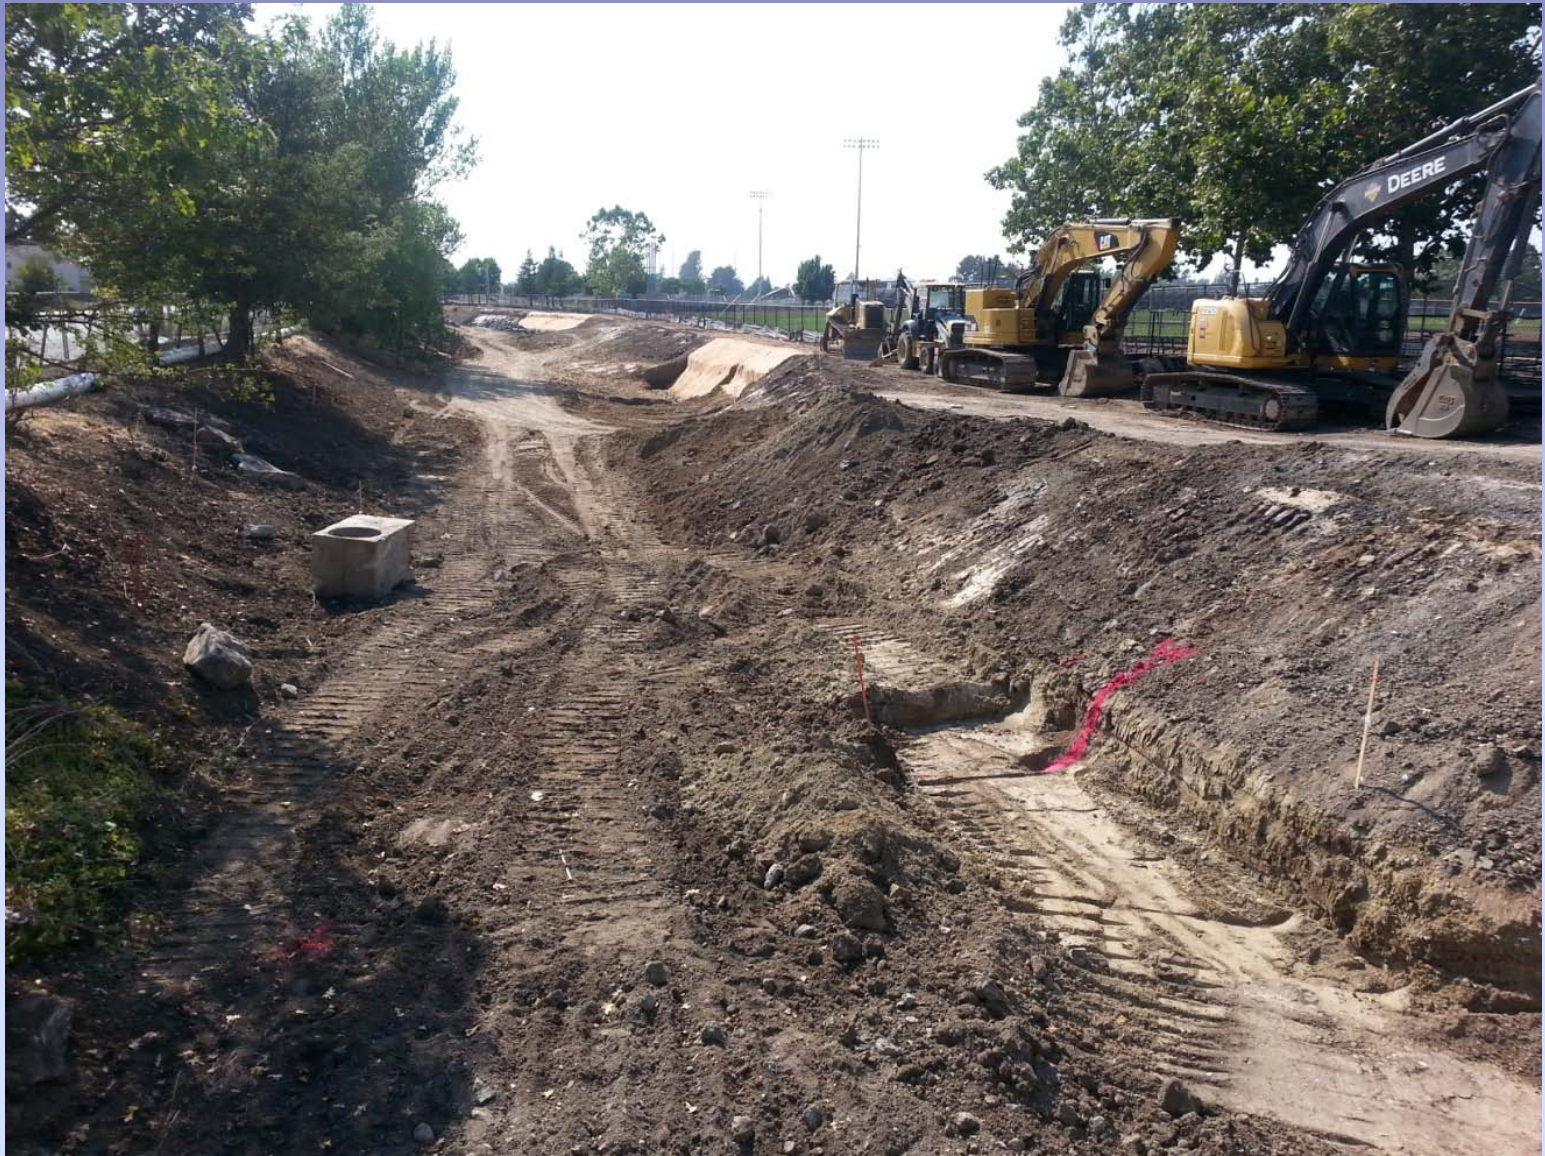
Widening the channel and sloping the bank.

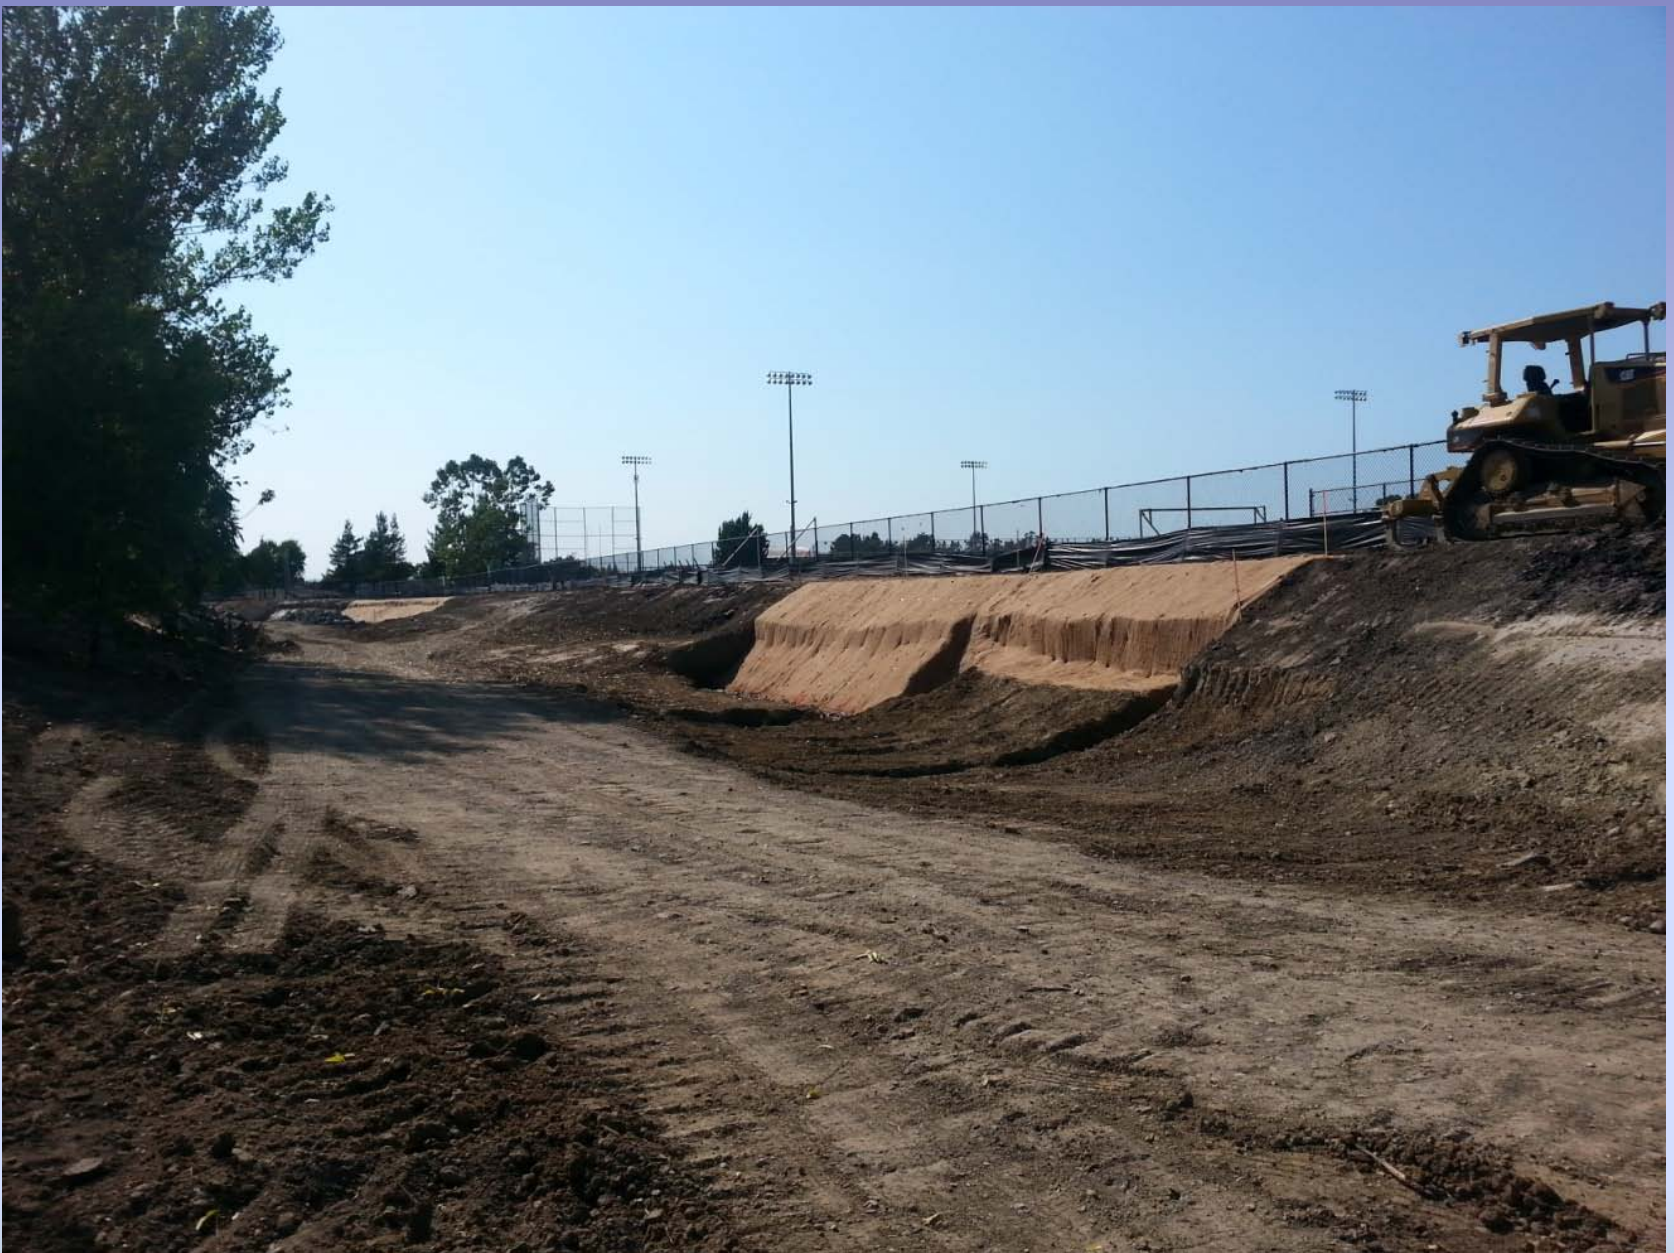
A blanket made of natural fibers covers the bare soil, to reduce erosion.

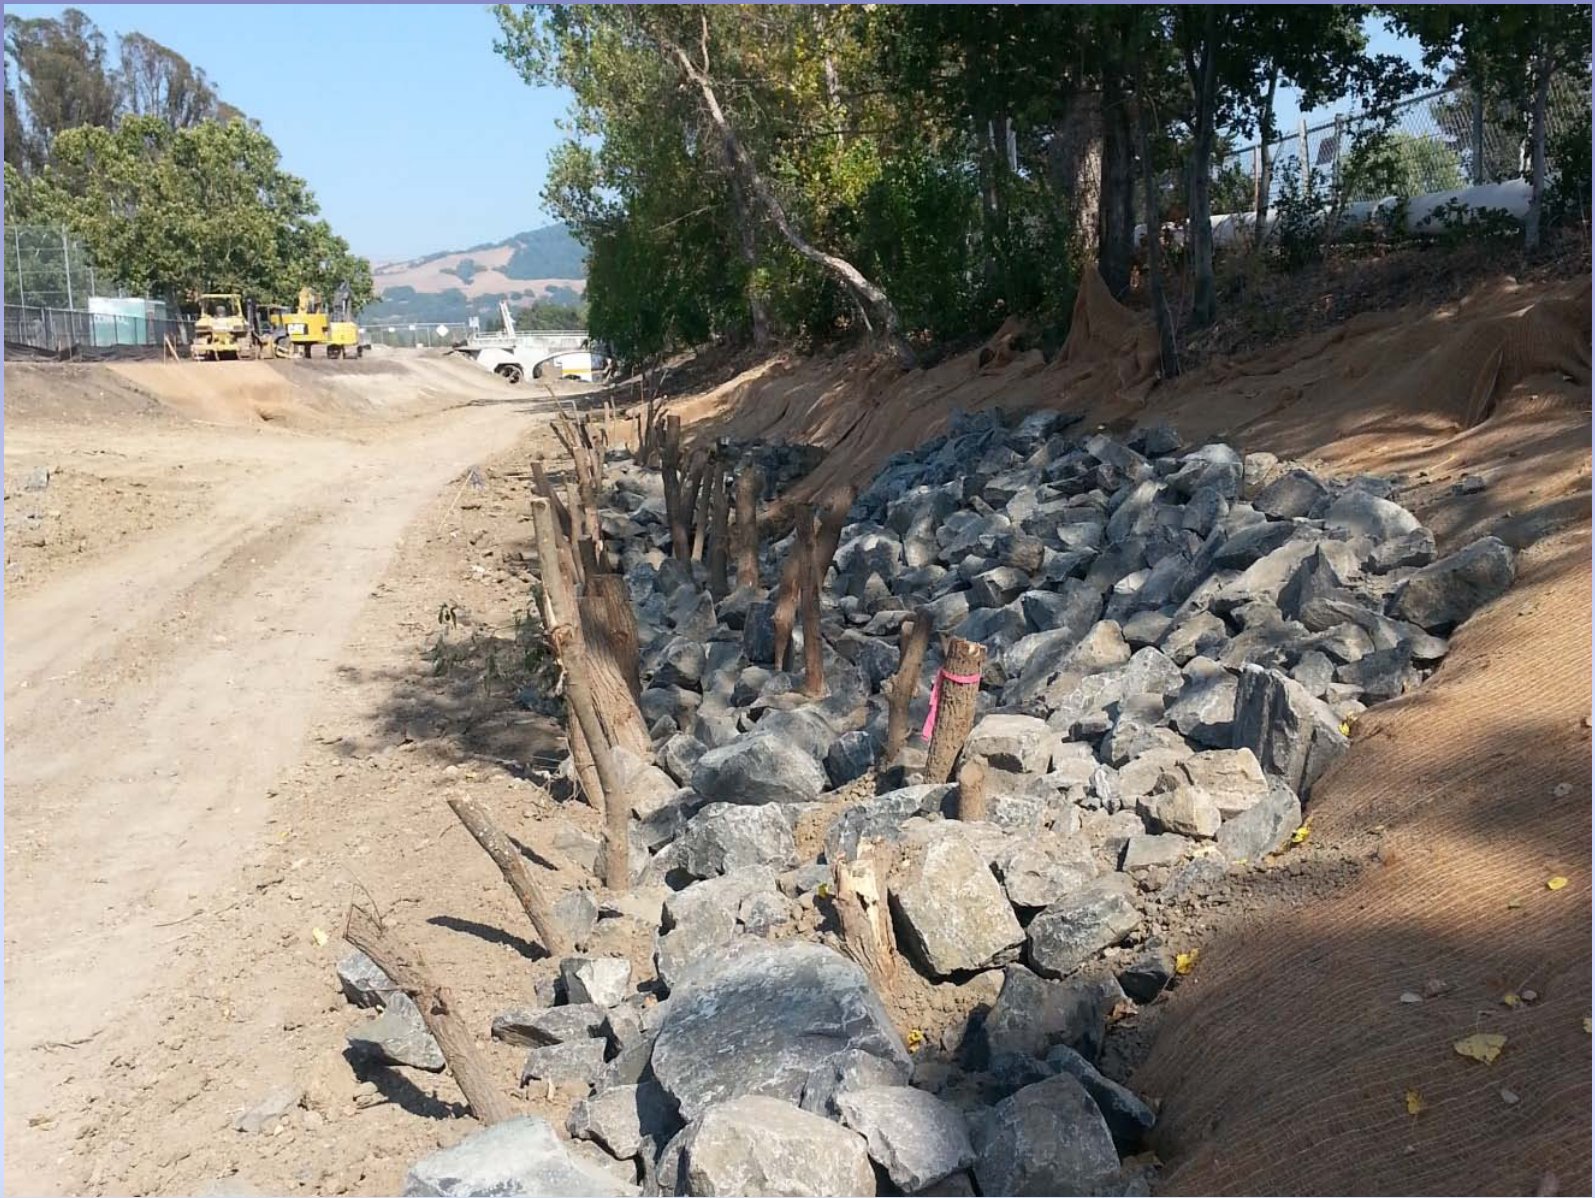
New boulders along the stream bank will help deflect the water and decrease erosion.

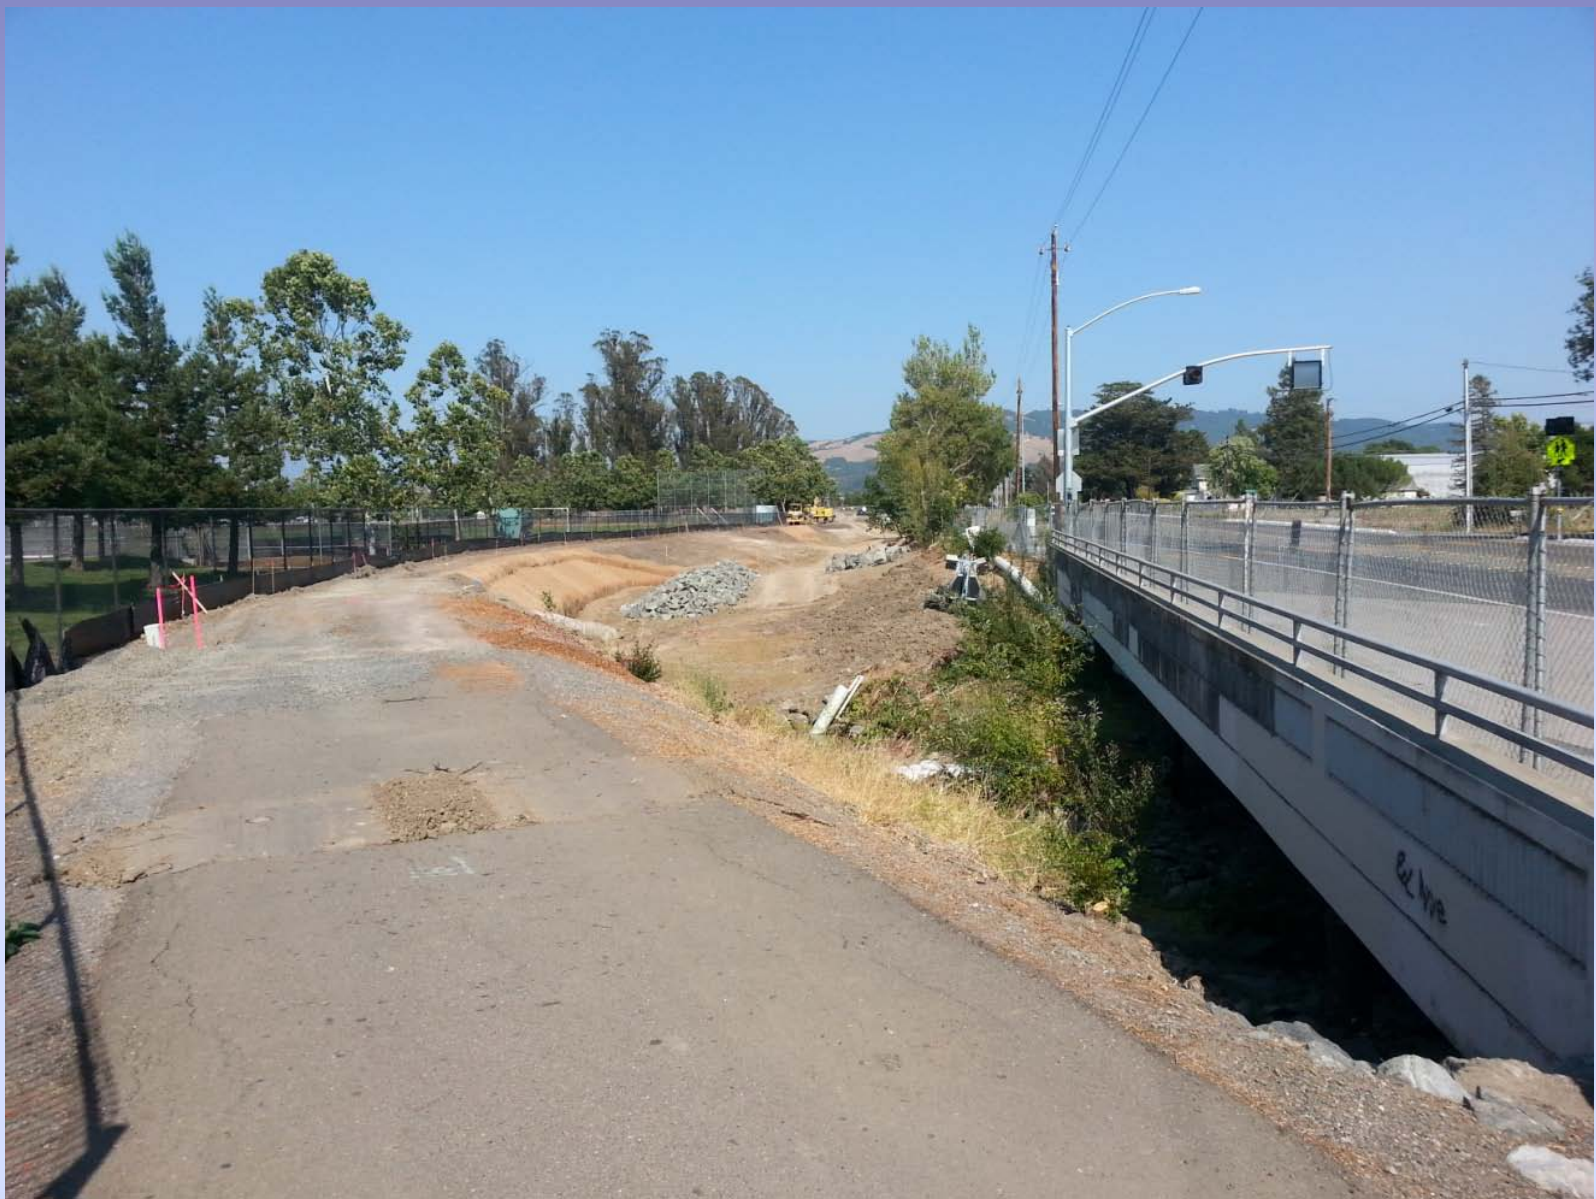
This is the creek at the place where it goes under Bellevue Avenue. Elsie Allen High School is to the left. The next photo is a close-up of this site.

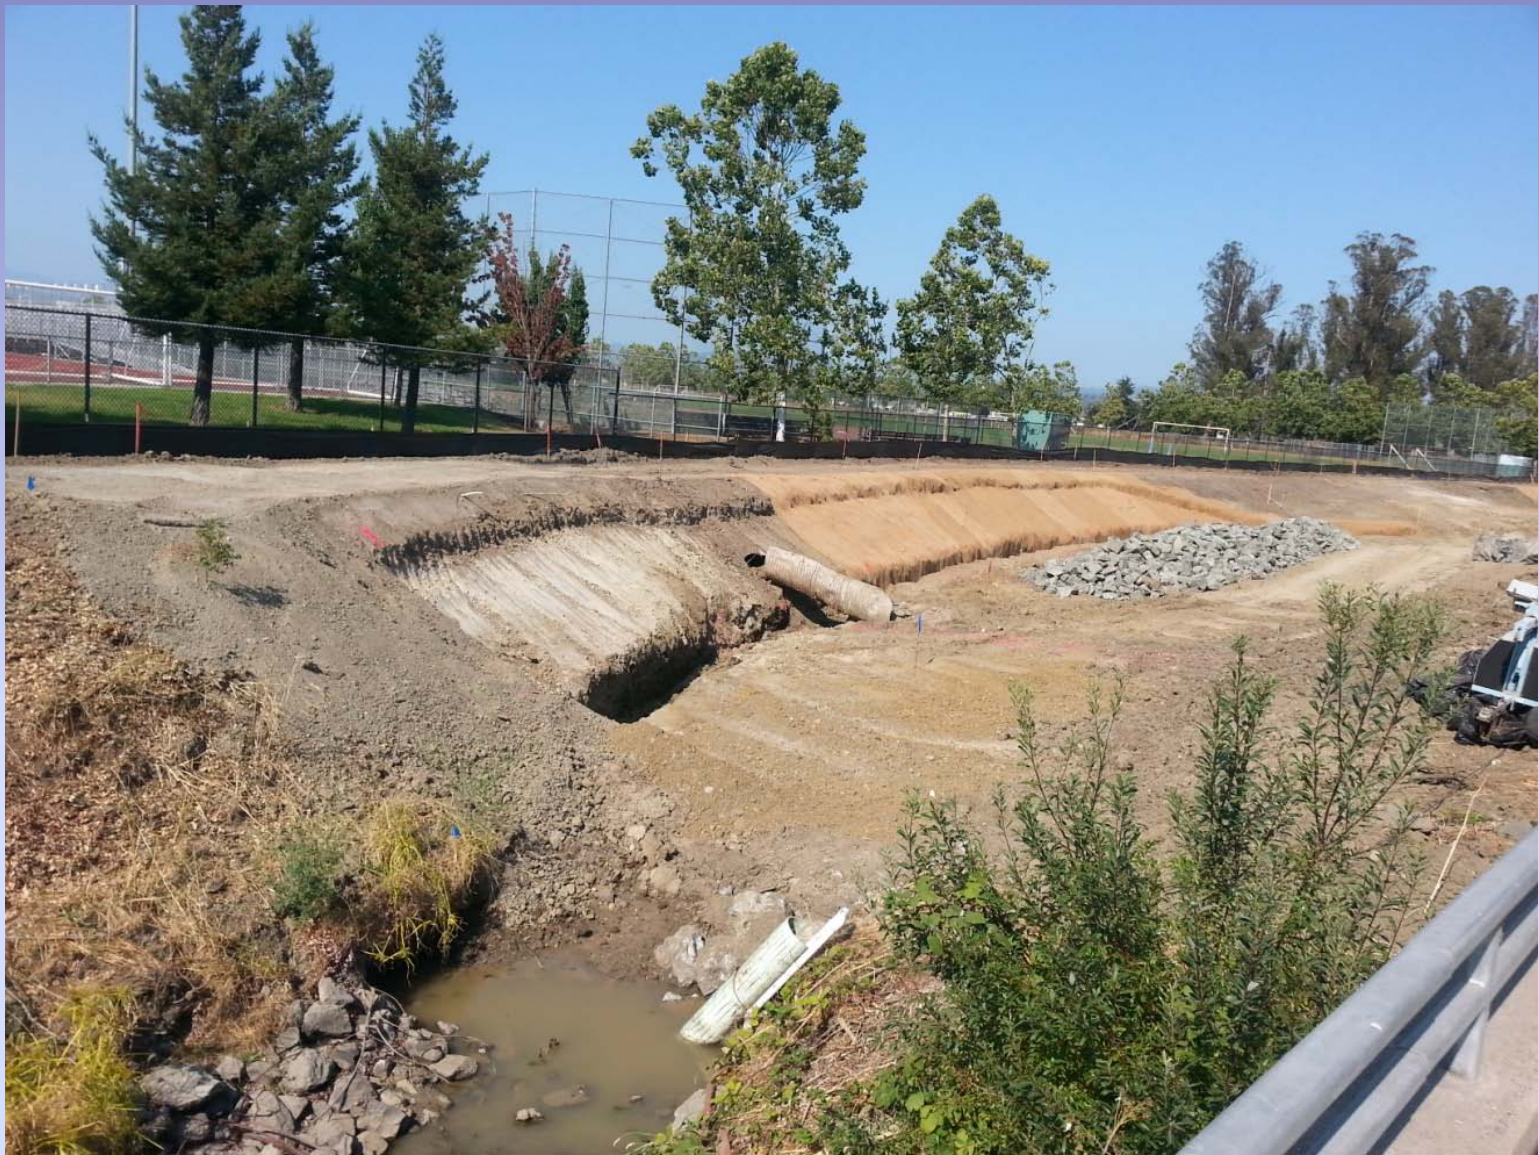
Reshaped channel at Bellevue. Notice the fiber netting placed over the bare streambank. This will help reduce erosion until the plants grow. The boulders will armor the bank.

Willow starts were planted right away, and they are already beginning to grow. Red flags mark the spots where other plants are taking root.

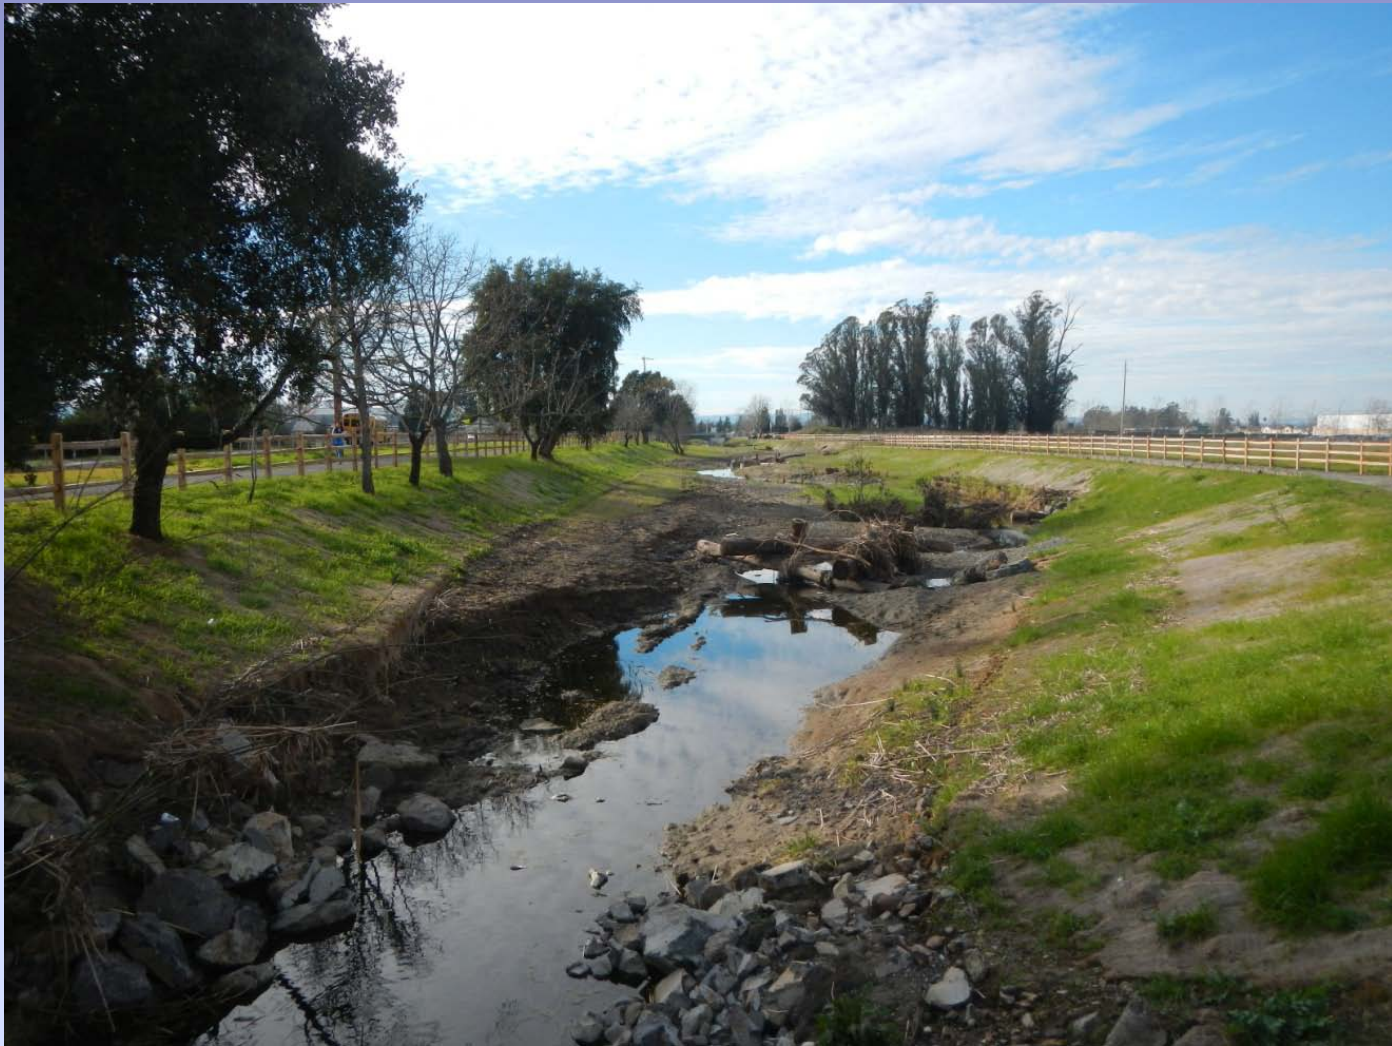
January, 2015

This is looking downstream from Dutton Meadow, six months after the restoration work. The channel is wider and connected to the flood plain, to the right. Logs and boulders will protect the banks and provide new habitat.

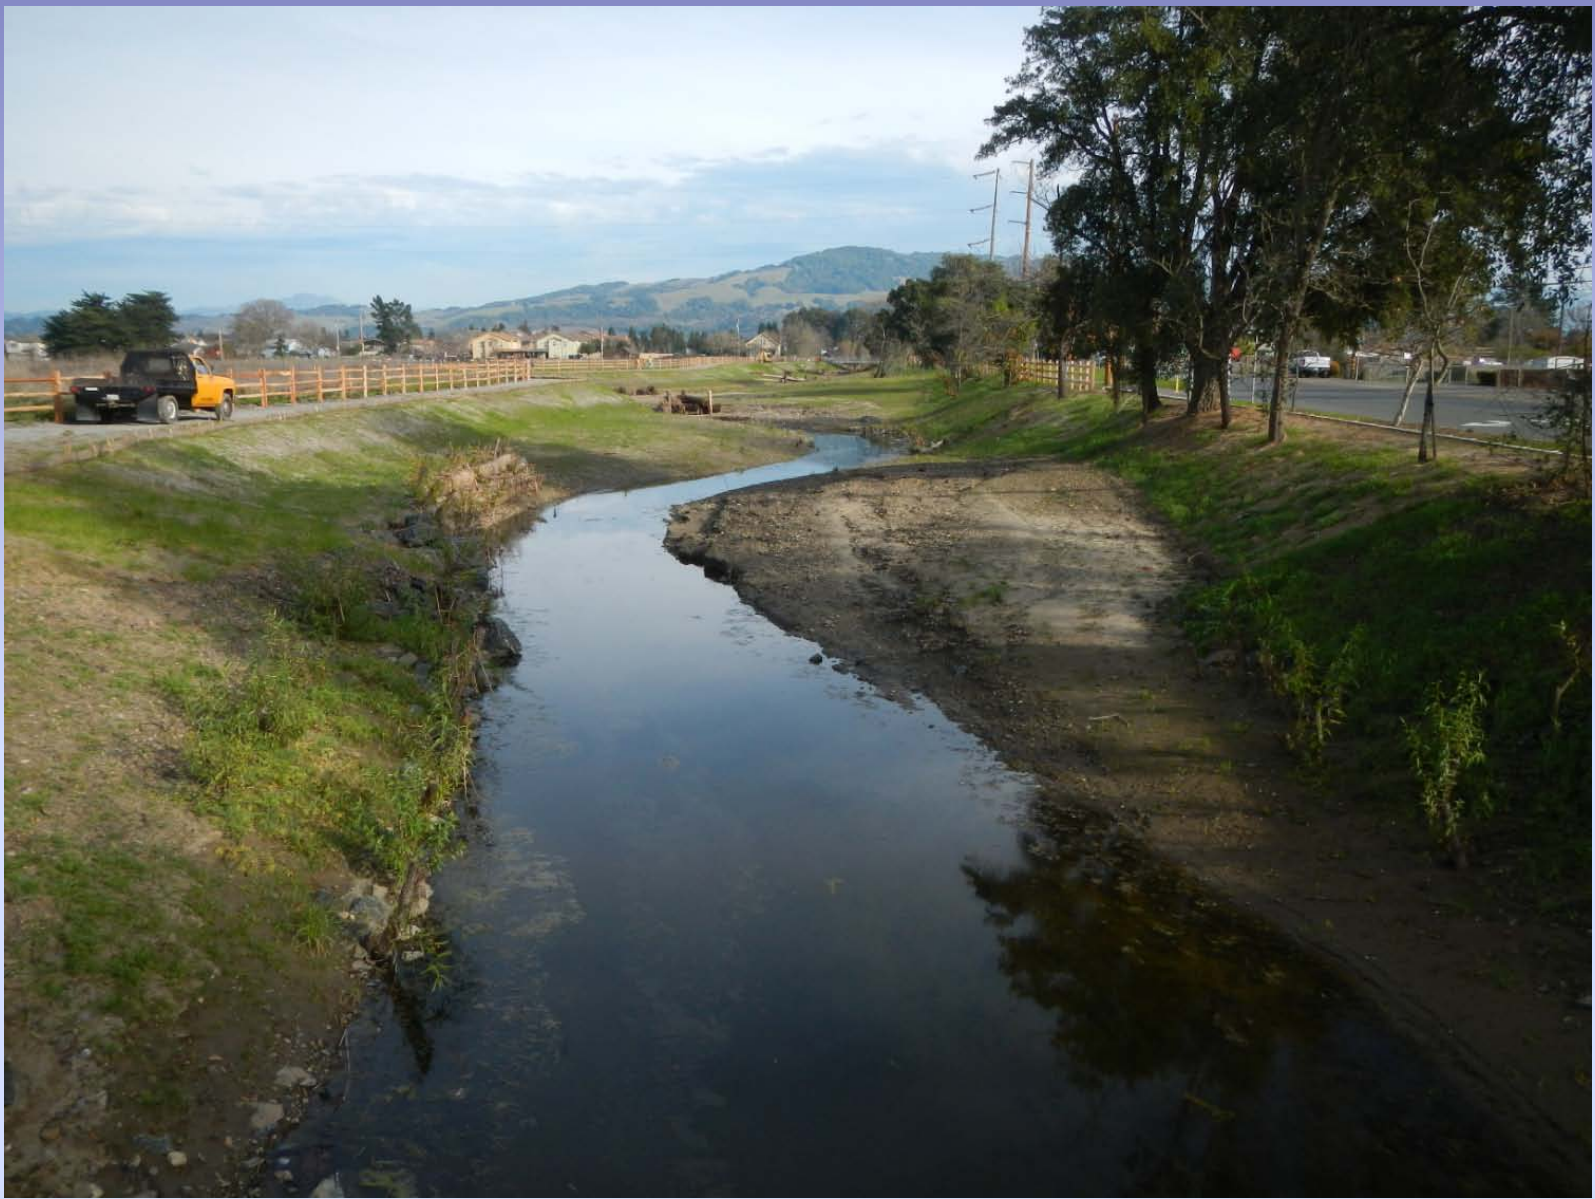
The creek now has curves that will help slow down the water. Logs and boulders on the outside of these curves will protect the streambanks.

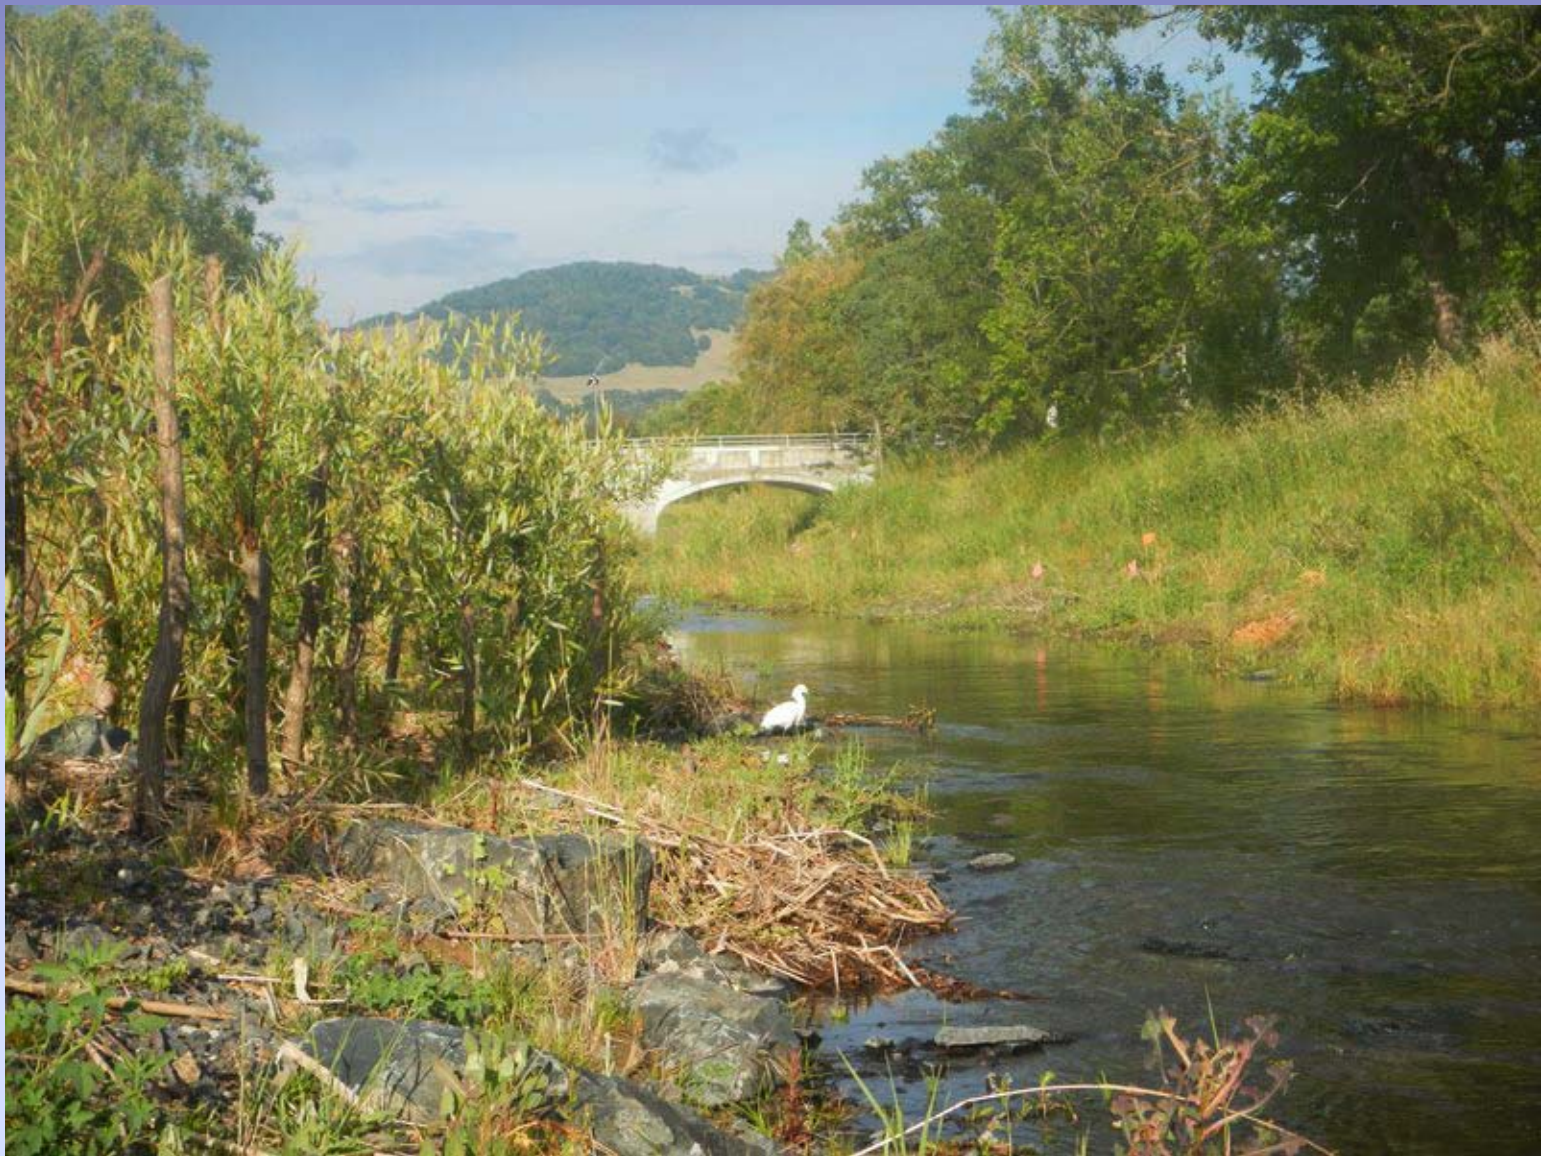
Willows grow long the left bank. By this time next year (2016) they will be shading the stream.
