Colgan Creek Restoration

In the summer of 2014, people worked to make a section of Colgan Creek more like the natural stream it used to be. This is called stream restoration.

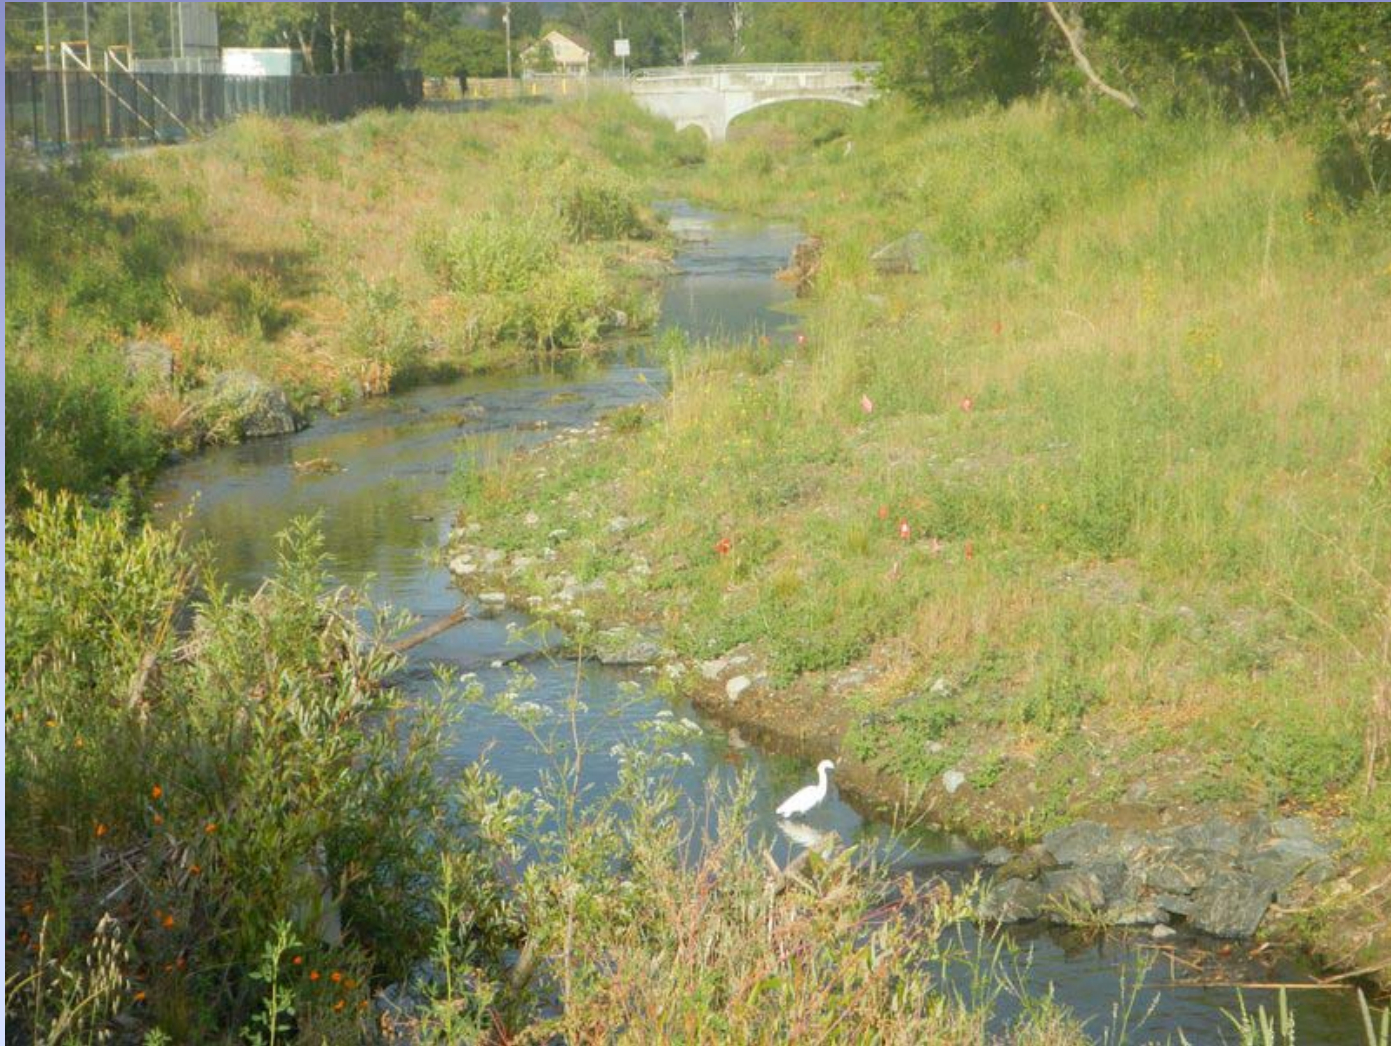
Willows grow long the left bank. By this time next year (2016) they will be shading the stream.

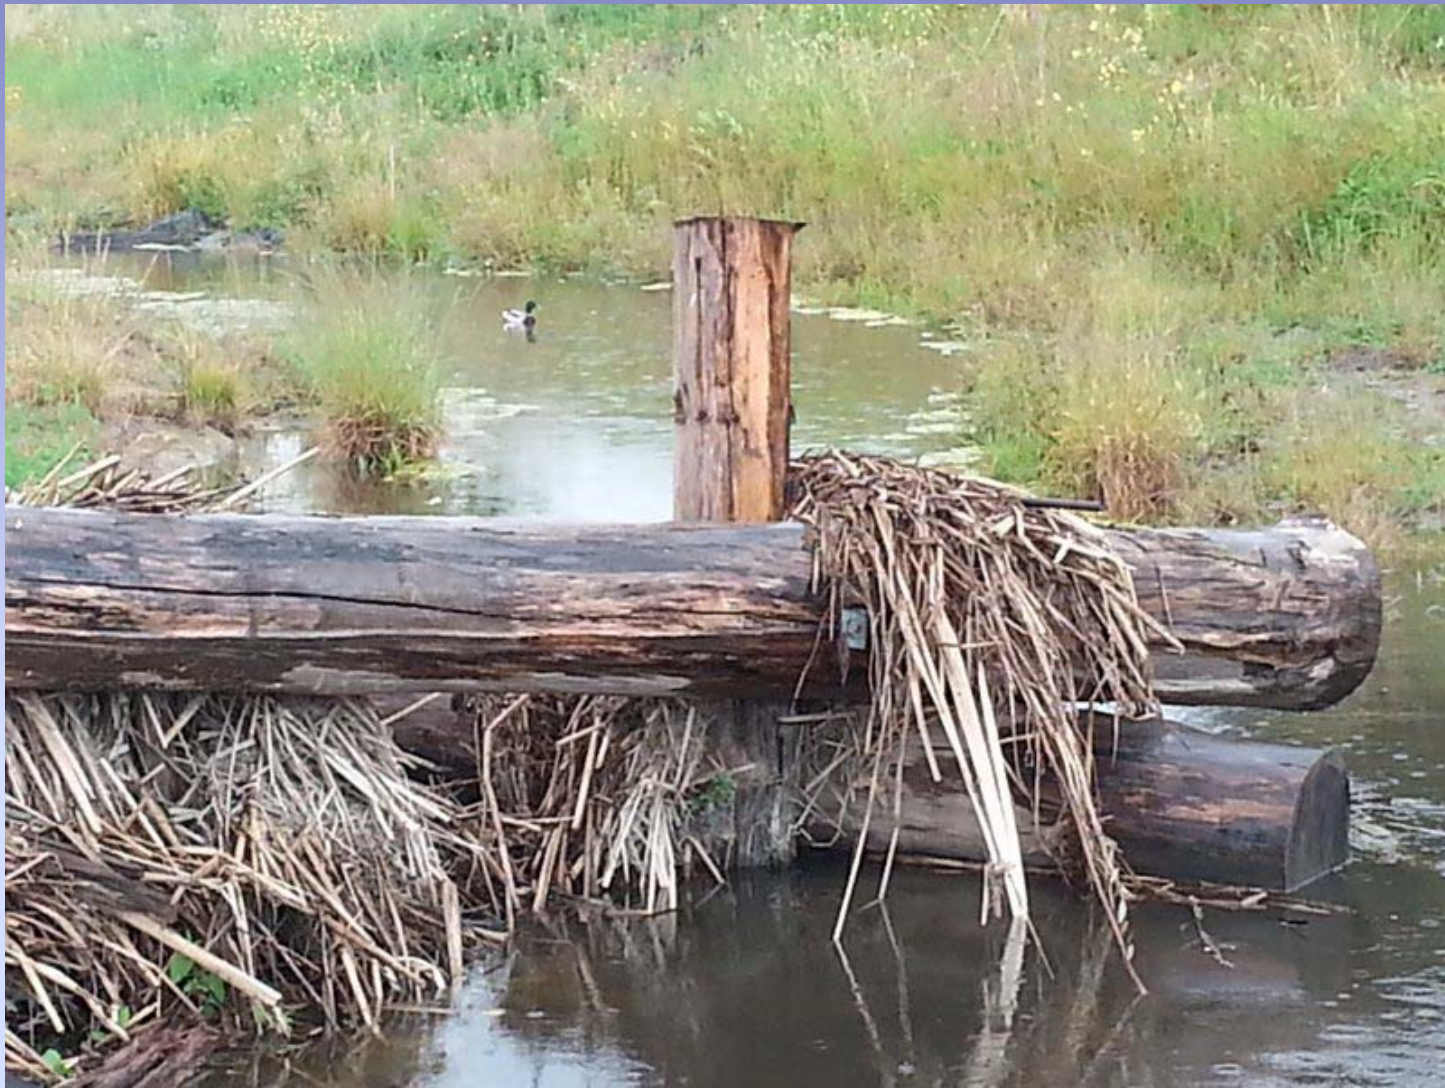
Newly placed structures, like these logs, will create more diverse habitat and help slow down the water during high flows.

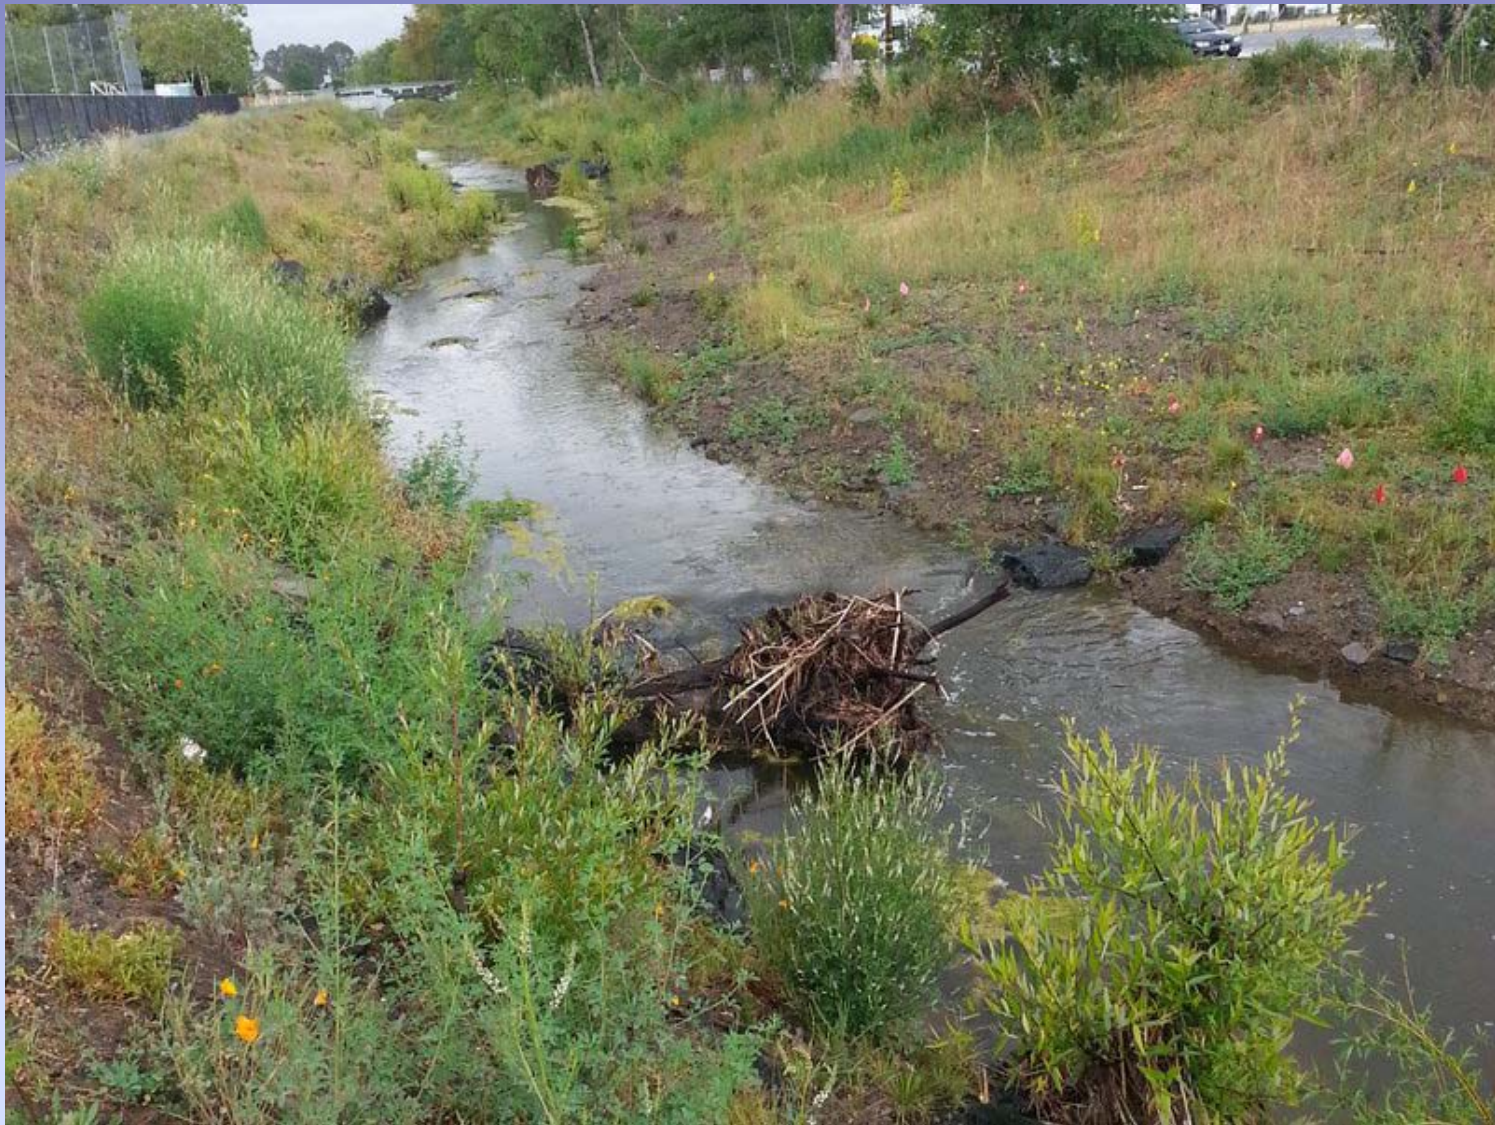
The stream channel is no longer choked with plants. Large wood and boulders divert the flowing water away from the banks.
