Stream Restoration

Examples of how streams
respond to restoration

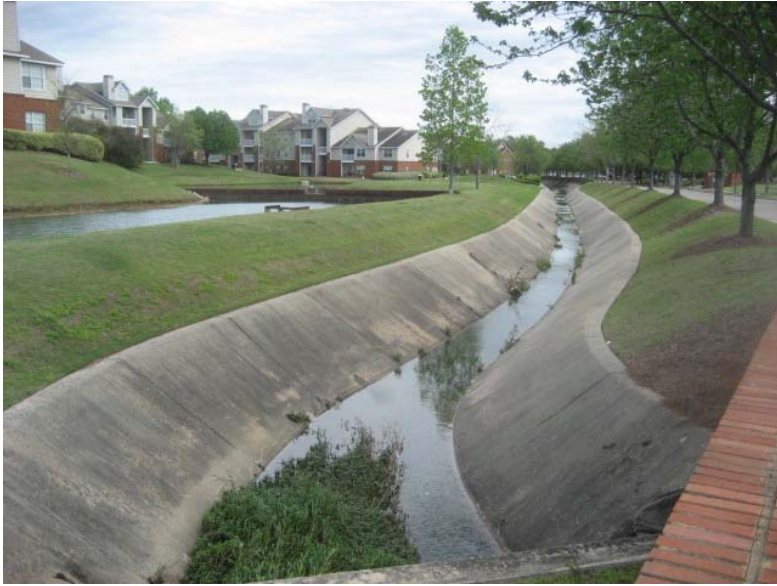
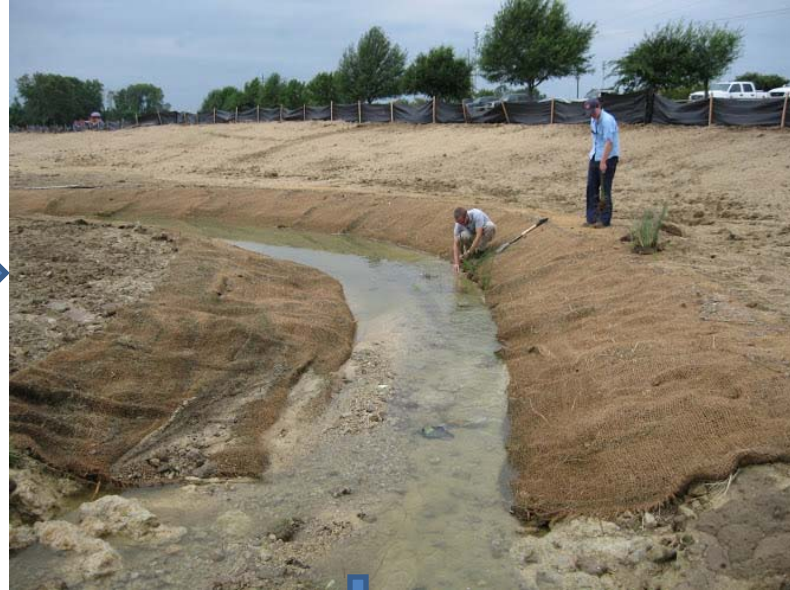
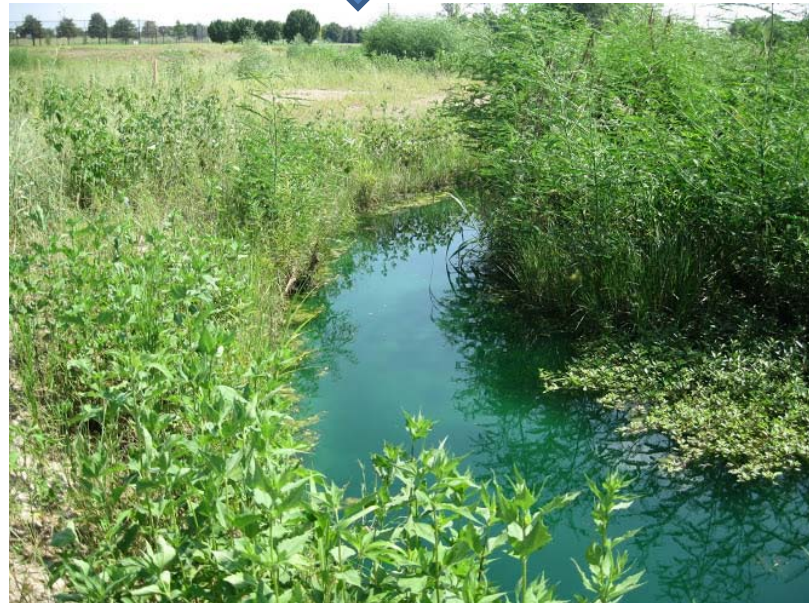
A restored urban stream in Alabama

The stream channel was made of cement and was straight. There were no trees close to the stream.

The cement is removed and curves were added. Native plants were planted.

After several years, plants have grown and the stream meanders.

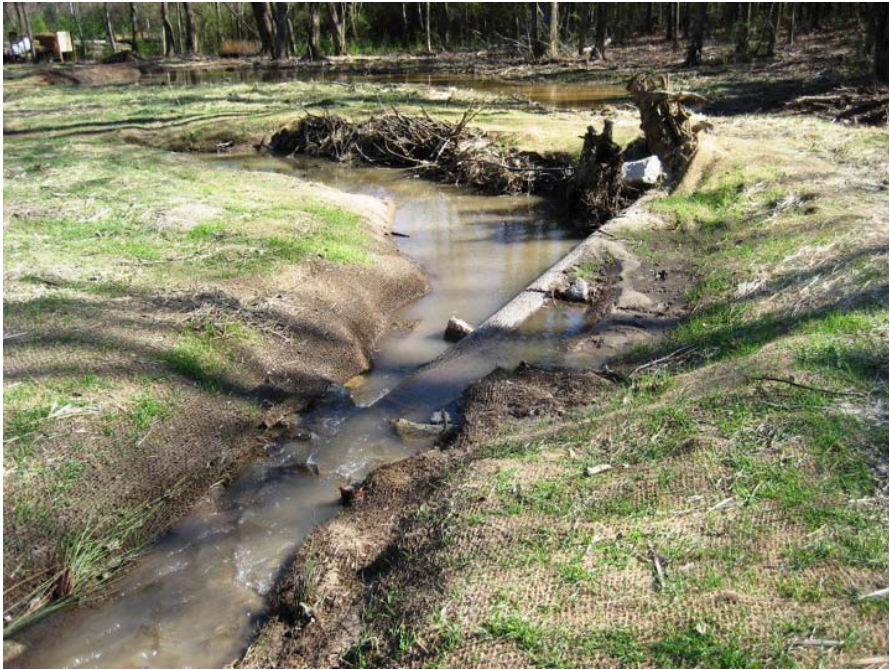
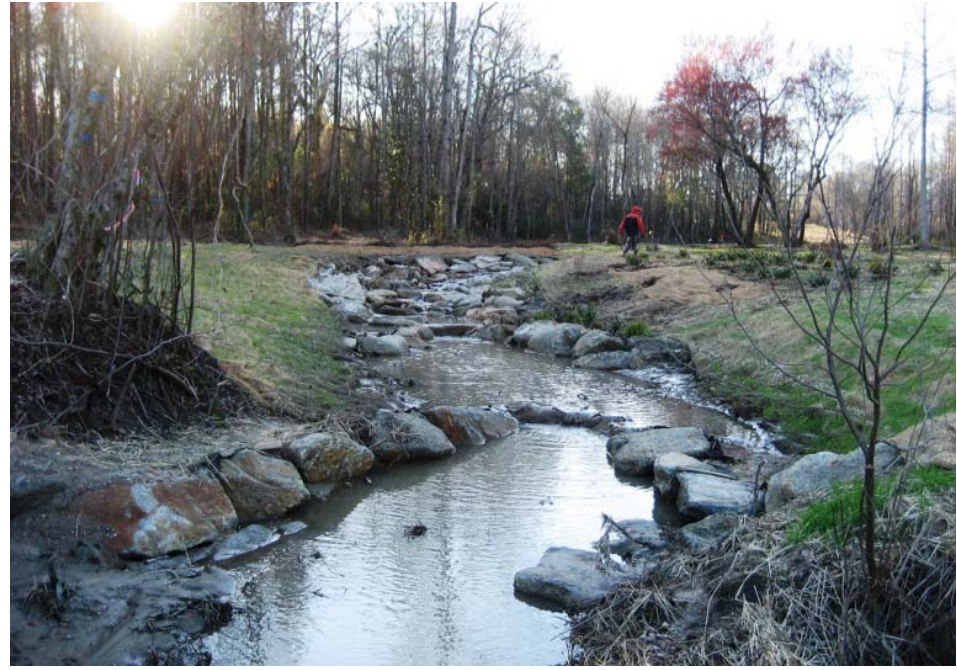
Instream Structures ~ logs, boulders

Adding logs and boulders helps deflect water from the streambanks. This decreases erosion and sedimentation. The instream structures also make good habitat for plants, insect, fish, and other animals.

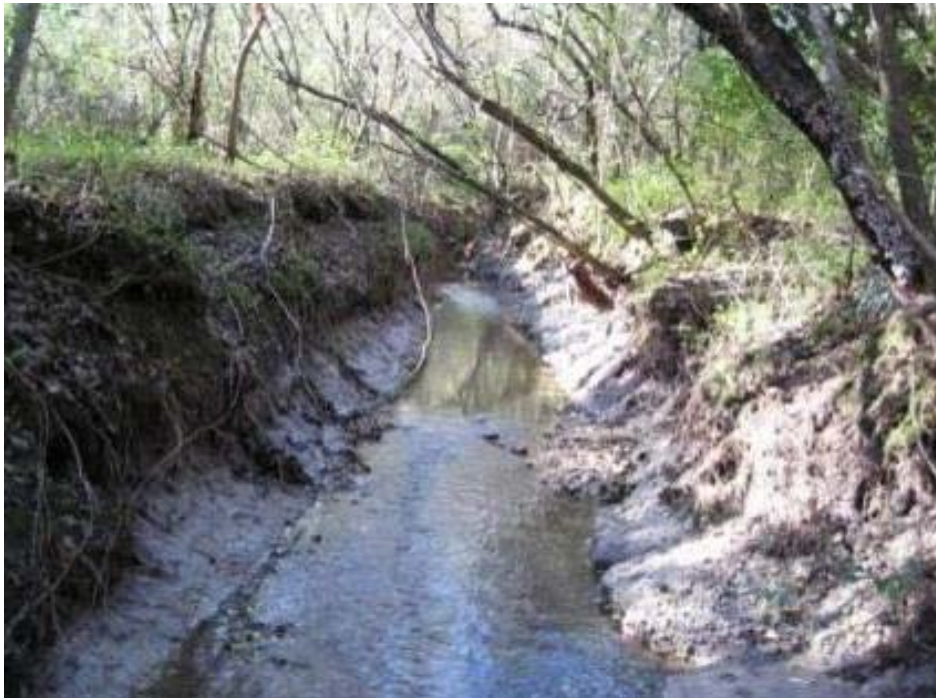
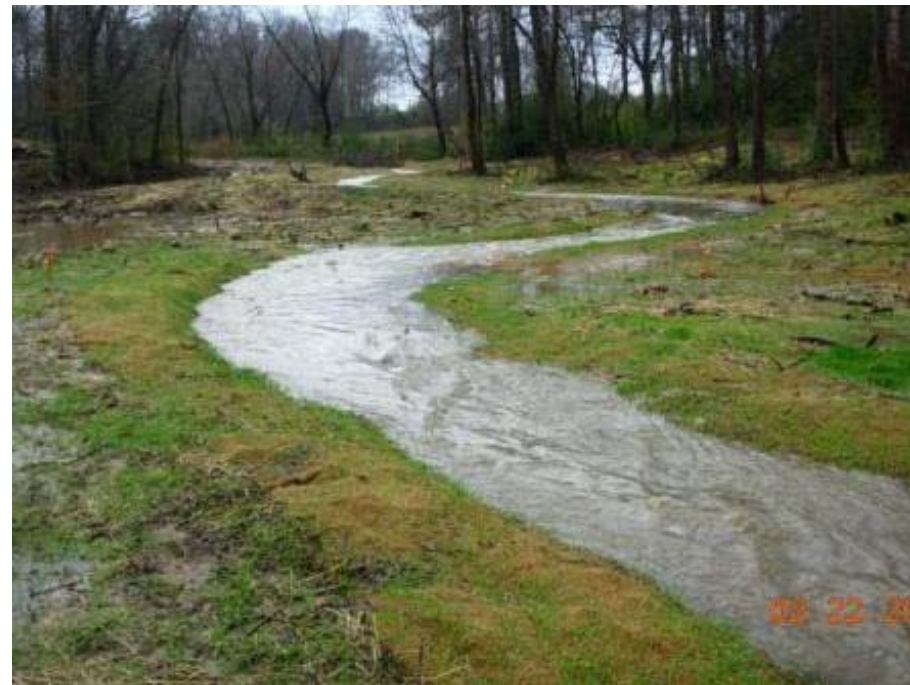
This stream in Alabama was disconnected from its floodplain. Flood water had nowhere to go, so it cut a deeper channel. Water also eroded the stream banks, making them unstable. Trees were falling over.

To restore the stream, people reshaped the banks, so that water can go into the floodplain during high flows. Curves (meanders) were also added.

Both of these changes decreased the energy of the flood water. Less energy in the water means less erosion.

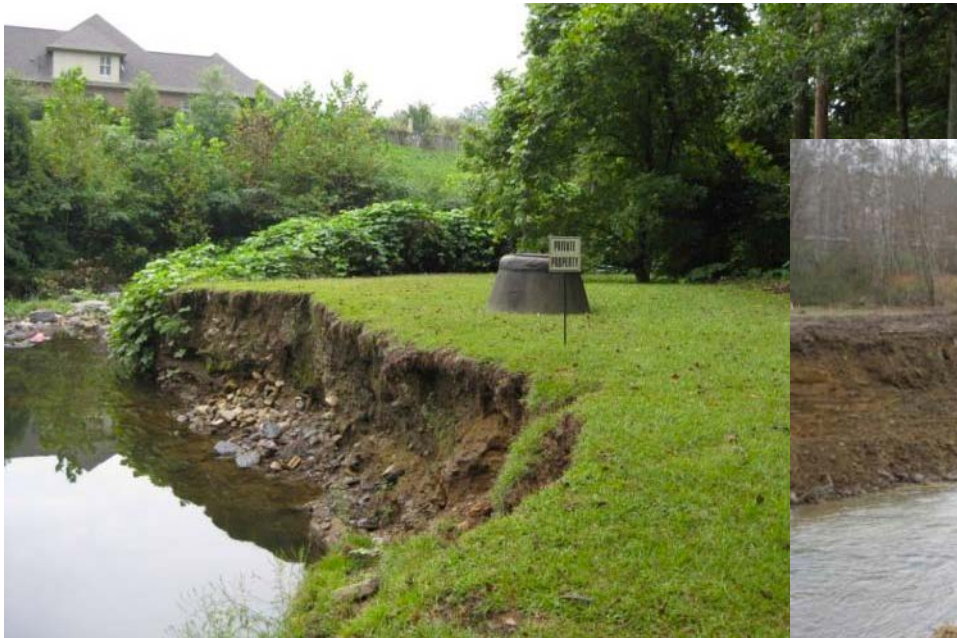
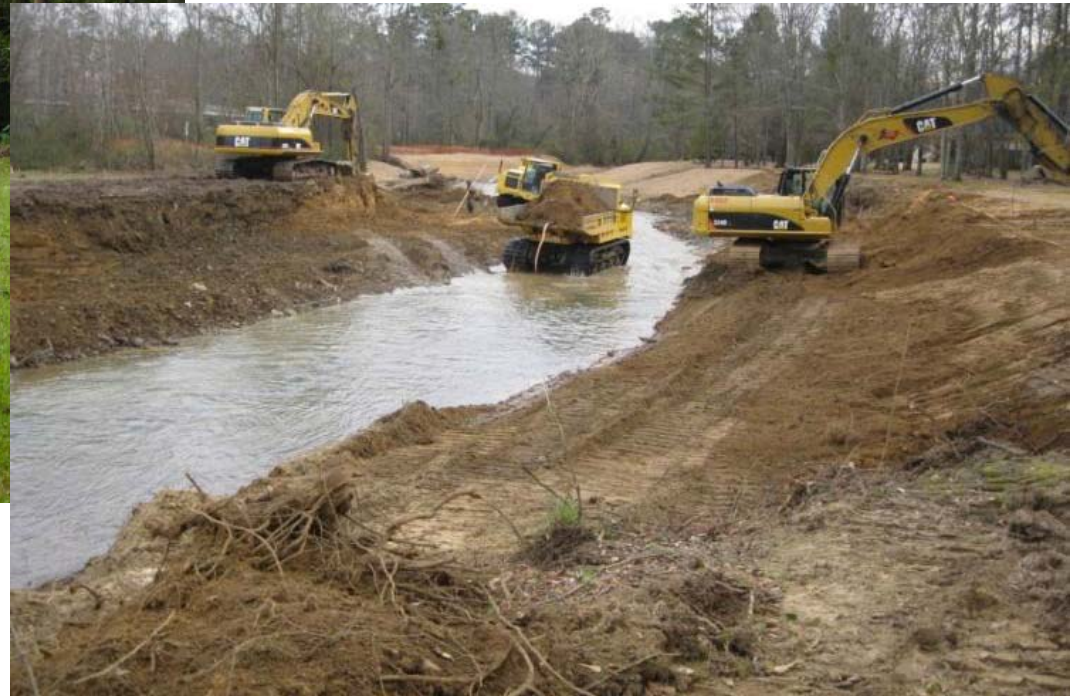
Another example of a stream getting deeper and the banks becoming unstable.

At first, when restoration work begins, it looks like a mess. But the new channel shape gives the water more area to flow into during floods. The water spreads out, slows down, and causes less damage.
